# FINAL FIRST FIVE-YEAR REVIEW REPORT FOR OPERABLE UNIT 2 AND OPERABLE UNIT 4 SCHOFIELD ARMY BARRACKS, ISLAND OF OAHU, HAWAII

Prepared for U.S. Department of the Army U.S. Army, Hawaii

Prepared by **Harding ESE**

Harding ESE Job No. 53744 06.01 Contract No. GS10F0157K Order No. DAPC50-01-F-0106

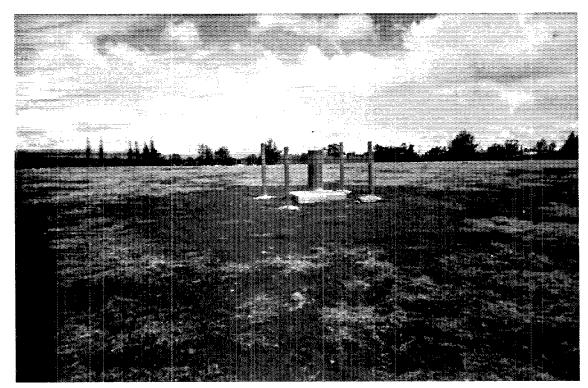
Most of the observations have been related to maintenance issues. The most significant observations have been swales and cracks that have formed due to settlement of the landfill contents. Additionally, sparse vegetation and corrosion of the protector casings on the monitoring wells have been observed.

Looking at one of the landfill gas monitoring venting wells - Note sparse vegetation

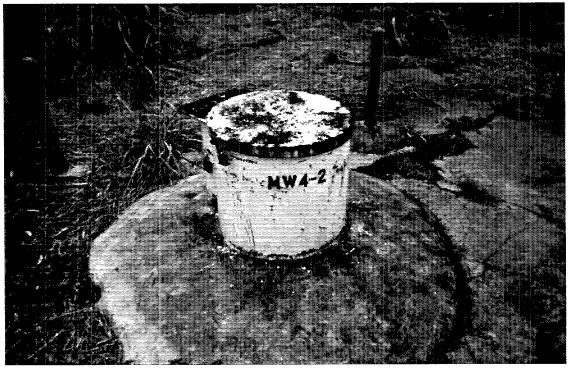
Groundwater Monitoring Well MW-4-2 - Note corrosion on casing

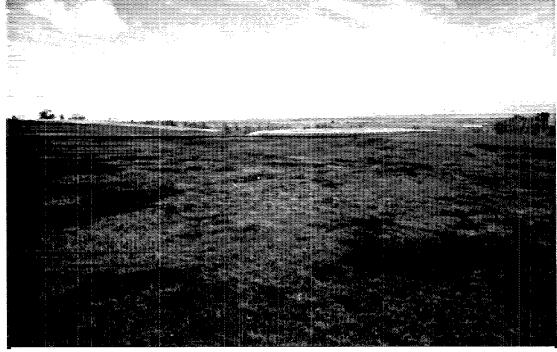
Sparse vegetation on landfill cover - view is from south end of landfill looking north

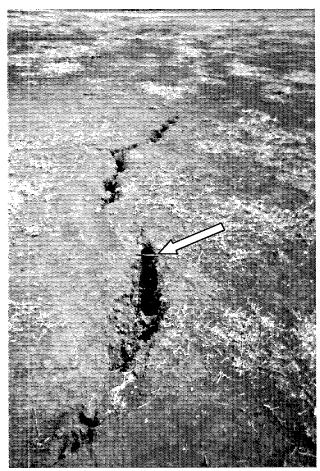
Looking at some of the cracks on the landfill cover – Note pen at crack for scale

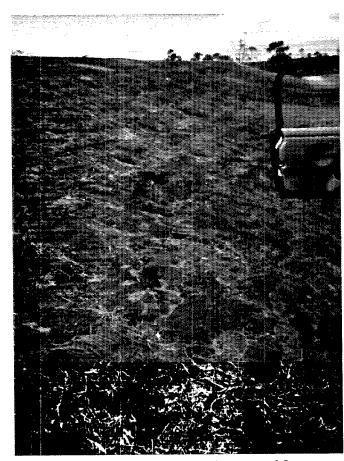
Some erosion and cracking on sideslope of Center Drainage Channel

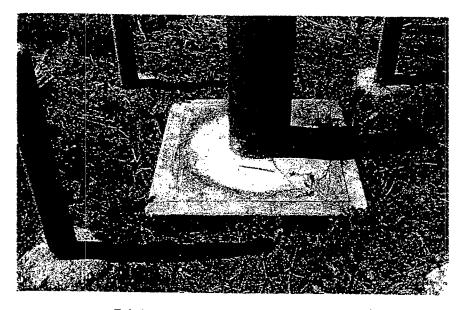
Existing hairline crack at base of gas vent #4

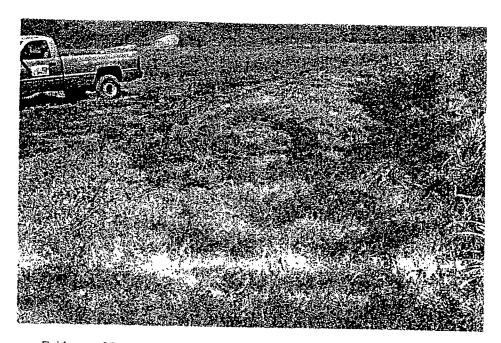
Evidence of Bermuda grass taking hold in northern area along backslope berm

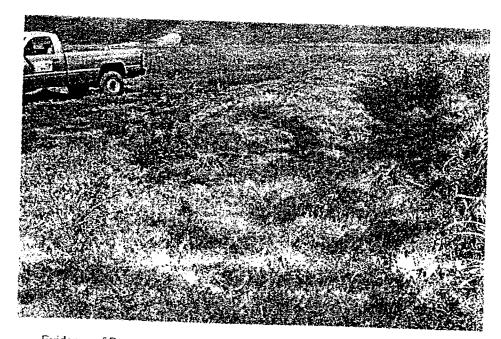
Evidence of Bermuda grass taking hold in northern area along backstope berm

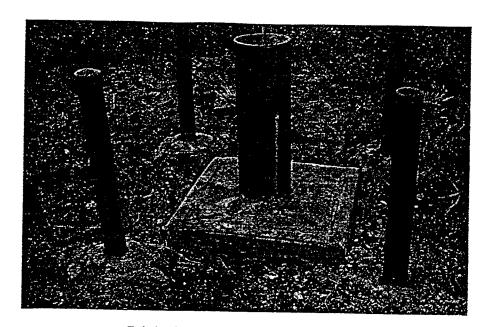
Existing hairline crack at base of gas vent #4
